# Home Inspection Report

**Inspection Address:**  
1234 Lovely Lane, Knoxville, TN

**Inspection Date:**  
January 1, 2010

**Report Number:**  
01-10

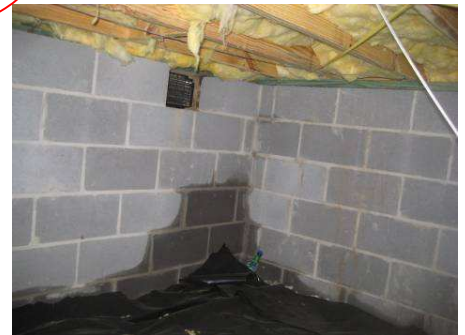
- **General Concerns:** The block foundation wall is wet and standing water was present at the rear right corner of the crawl space. The vast majority of crawl space leakage problems are the result of improper grading and insufficient control of storm water at the surface. All yard grading should slope a minimum of 6 inches over the first 10 feet out away from the foundation wall. Gutters and downspouts should collect roof water and drain the water at least 5 feet from the foundation. A lead-off drain should be installed to the downspout above this corner to discharge roof drainage away from the foundation wall. Continue to monitor this area after improvements to the drainage to assure that dry conditions are restored and maintained. (ref. chapter #19 Drainage Problems)

- 8) The block foundation wall is wet and standing water was present at the rear right corner of the crawl space. The vast majority of crawl space leakage problems are the result of improper grading and insufficient control of storm water at the surface. All yard grading should slope a minimum of 6 inches over the first 10 feet out away from the foundation wall. Gutters and downspouts should collect roof water and drain the water at least 5 feet from the foundation. A lead-off drain should be installed to the downspout above this corner to discharge roof drainage away from the foundation wall. Continue to monitor this area after improvements to the drainage to assure that dry conditions are restored and maintained. Refer to the photo on the Structural Section of this report for further information. (ref. chapter #19 Drainage Problems)

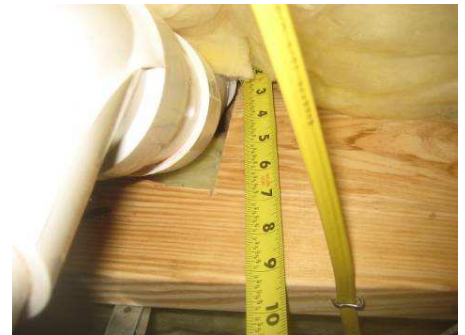
- **General Concerns:** Three floor joists have been excessively notched to allow passage of the plumbing drains below both main floor bathrooms. Repairs will be required to return the joists to the original design strength.

- 1) Three floor joists have been excessively notched to allow passage of the plumbing drains below both main floor bathrooms. Repairs will be required to return the joists to the original design strength. Please refer to the photo in the Structural Section of this report for further information.

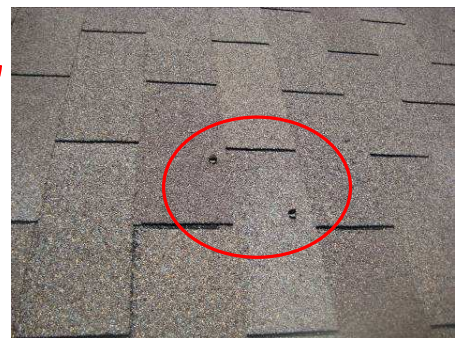
- **General Concerns:** Several nail heads have protruded through the asphalt shingles along the right and left sides of the roof above the garage. Several other shingles have slightly risen up from the roof surface. This is a common problem when nails back out of the roofing surface as the roof sheathing dries out after initial installation. All damaged shingles should be replaced and all raised shingles should be re-nailed and sealed.

- 9) Several nail heads have protruded through the asphalt shingles along the right and left sides of the roof above the garage. Several other shingles have slightly risen up from the roof surface. This is a common problem when nails back out of the roofing surface as the roof sheathing dries out after initial installation. All damaged shingles should be replaced and all raised shingles should be re-nailed and sealed. Please refer to the photo in the Roofing Section of this report for further information.

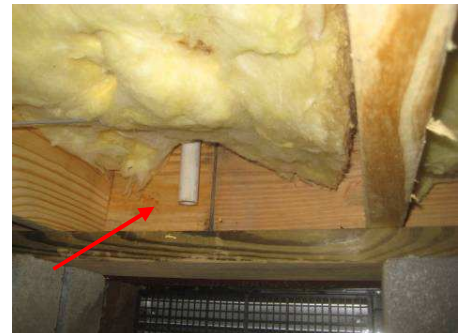
- **General Concerns:** The plumbing drain from the safety catch pan in the laundry room terminates in the crawl space. This drain should be extended to the exterior to provide proper drainage and allow observation in the event that a leak occurs.

- 17) The plumbing drain from the safety catch pan in the laundry room terminates in the crawl space. This drain should be extended to the exterior to provide proper drainage and allow observation in the event that a leak occurs. Please refer to the photo in the Plumbing Section of this report for further information.
